FENWICK SOLAR FARM

Preliminary Environmental Information Report

Volume III Appendix 10-7: Tree Survey Report

March 2024

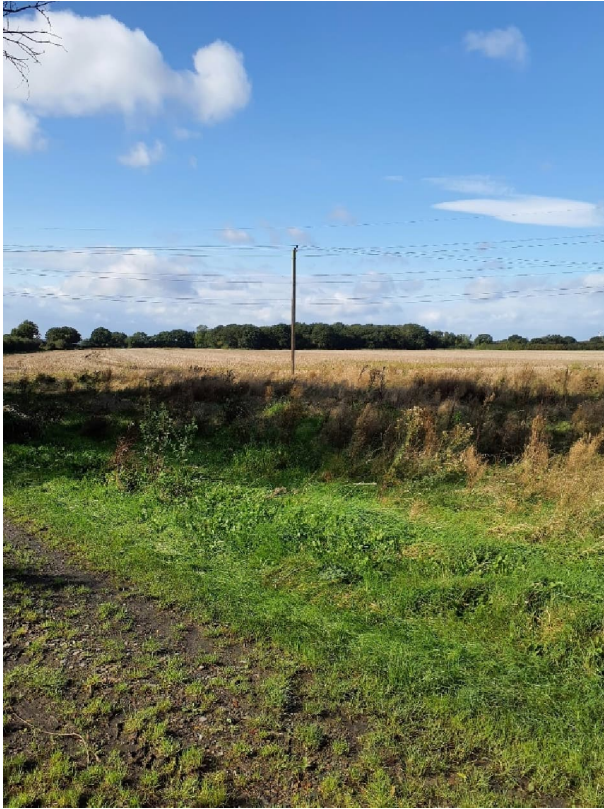
Plate C-1 View of W349 looking northwest.

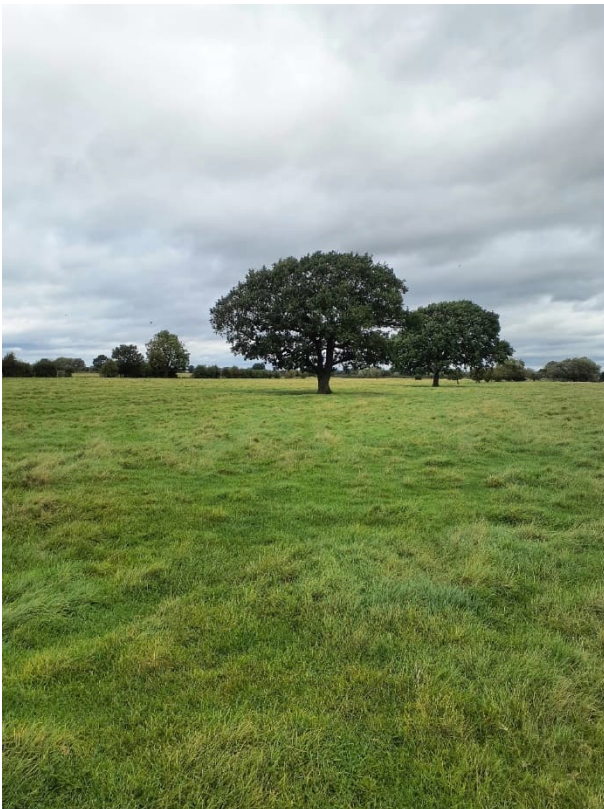
Plate C-2 T709 looking northwest.

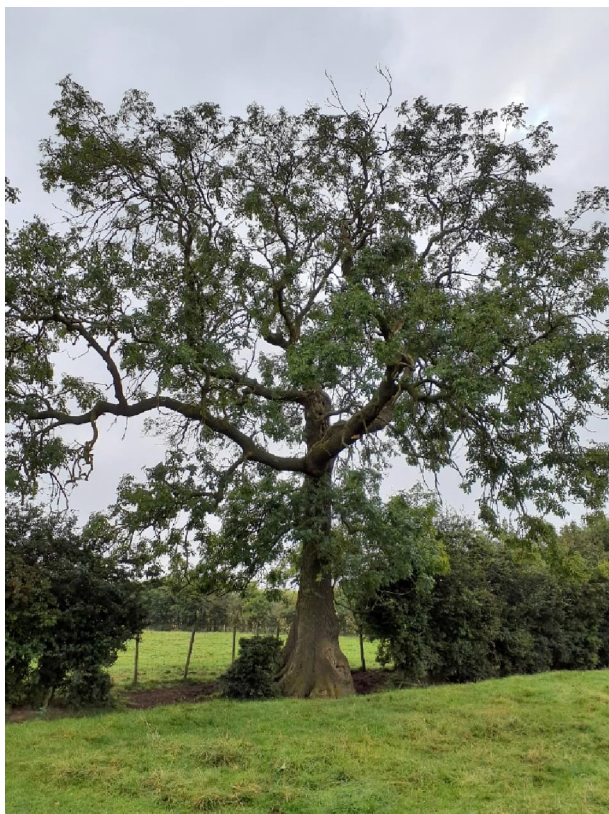
Plate C-3 T618 looking east.

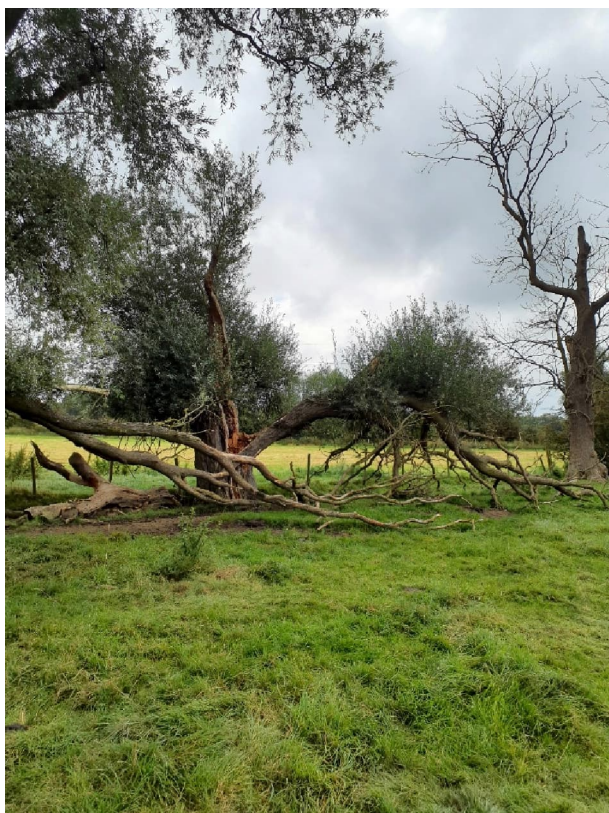
Plate C-4 T626 looking west.
